**CWA COMPLIANCE EVALUATION INSPECTION REPORT
U.S. ENVIRONMENTAL PROTECTION AGENCY, REGION 5**

Purpose: Compliance Evaluation Inspection

Facility: Benton Dairy, LLC

Date of Inspection: April 28 and 29, 2021

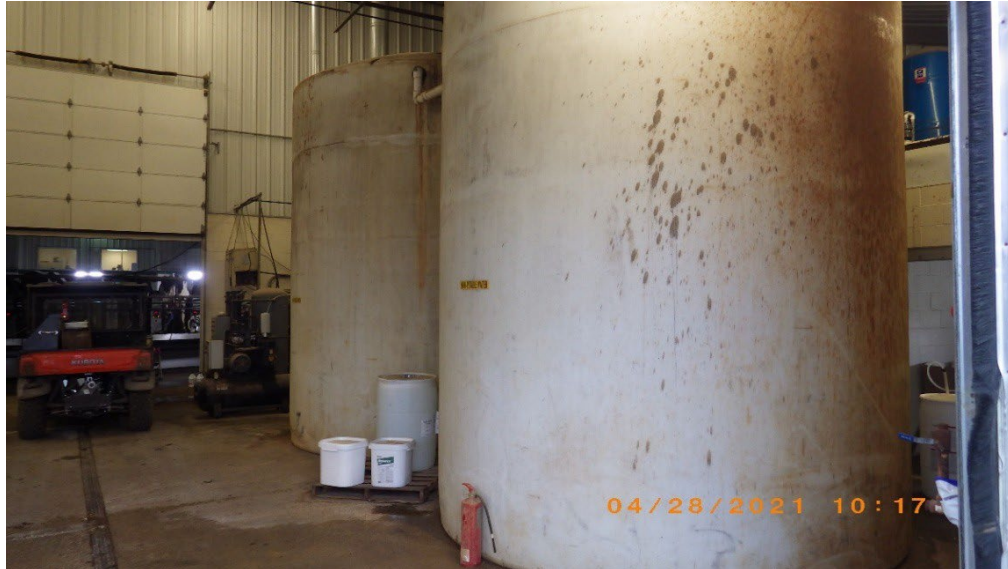
Photo Number: RIMG0068

Description: The noncontact cooling water tanks used to clean the Milking Parlor and provide water to the cows.

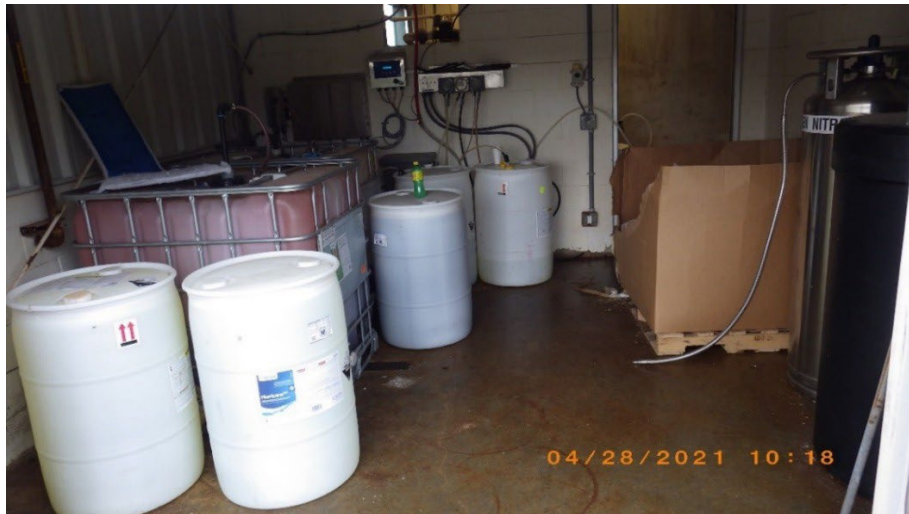
Photo Number: RIMG0070

Description: A second chemical storage Area with drains inside the building that convey any spill to the Recirculation Pit between Barns 2 and 3.

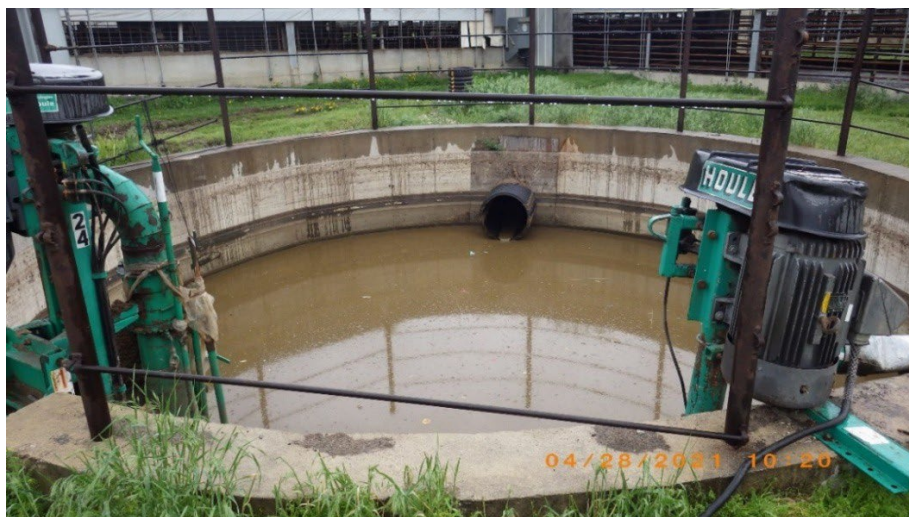
Photo Number: RIMG0071

We continued to the north side of the Milking Parlor where we observed the Chemical Storage Area. The Chemical Storage Area held teat dip, formaldehyde, and other chemicals. EPA observed drains in the Chemical Storage Area, which Mr. Benton explained would drain into the Sand Separation Lane (Photos RIMG0067 and RIMG0070) if there was a leak or spill from the chemicals. We continued to walk between Barn 2 and Barn 3 to the Recirculation Pit. The Milking Parlor has a drain that collects manure and process wastewater. The drain flows by gravity into the Recirculation Pit (Photo RIMG0071).

Description: Recirculation Pit. Process wastewater from the clean out of the Milking Parlor gravity flows into the Recirculation Pit. The water within the Recirculation Pit is used to clean out the holding area for the cows.

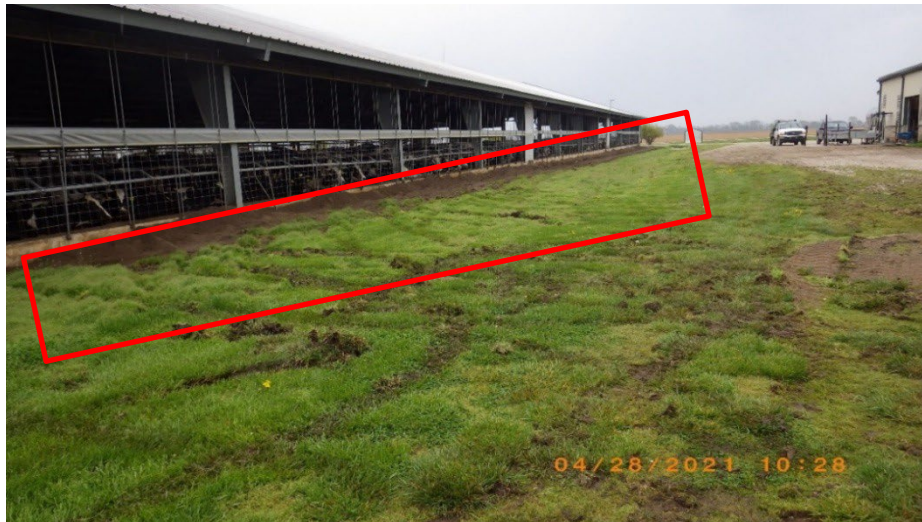
Photo Number: RIMG0072

Description: Flow from between Barn 3 and Barn 2 flows to the east. Bedding from Barn 2 is pushed out of Barn 2 on the south side of the Barn 2. The red outlined box shows the bedding pushed out of Barn 2.

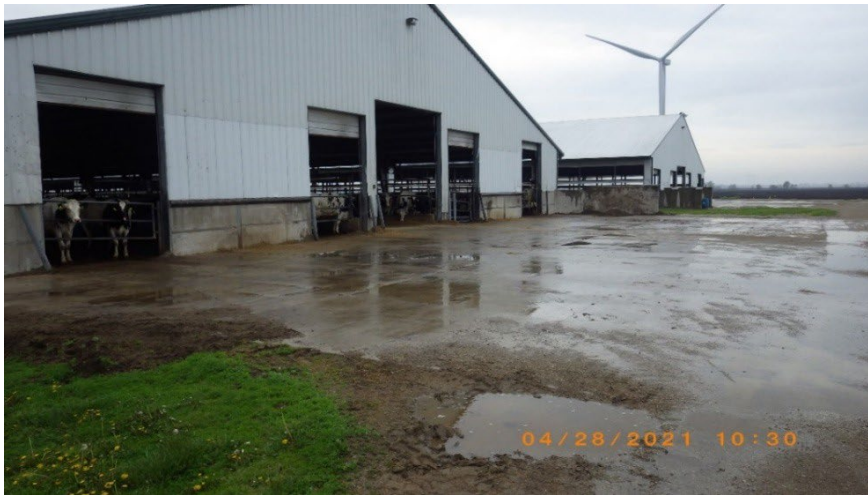
Photo Number: RIMG0073

Description: Barn 2 had some used bedding that was outside the doors on the east side of the barn and mixed with stormwater. The stormwater flows into drainage tile inlets between the Barns and outlets into the East Drainage Channel.

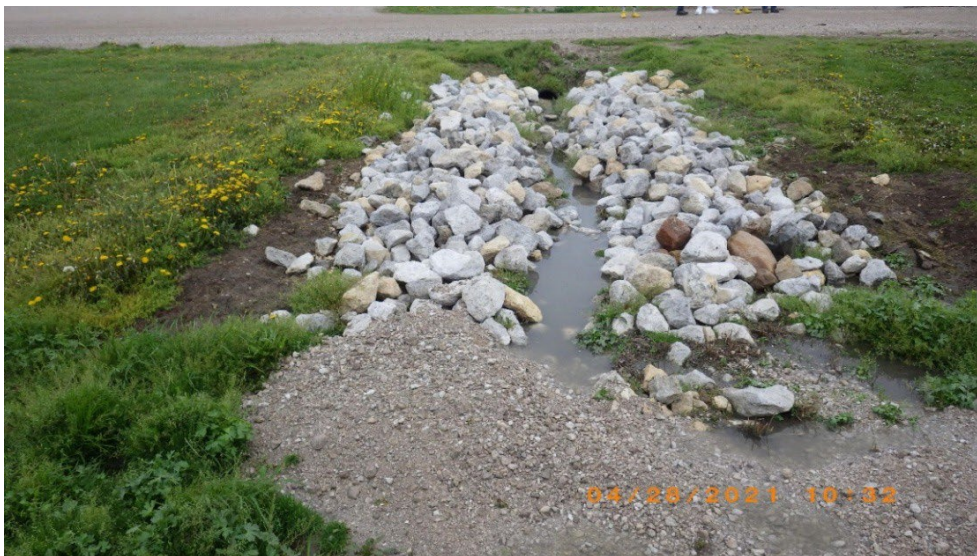
Photo Number: RIMG0076

Description: The drainage tile outlets the flow collected from between Barn 2 and Barn 3 through the drainage tile between Barn 2 and Barn 3 and conveys flow under the East Access Road into the East Drainage Channel.

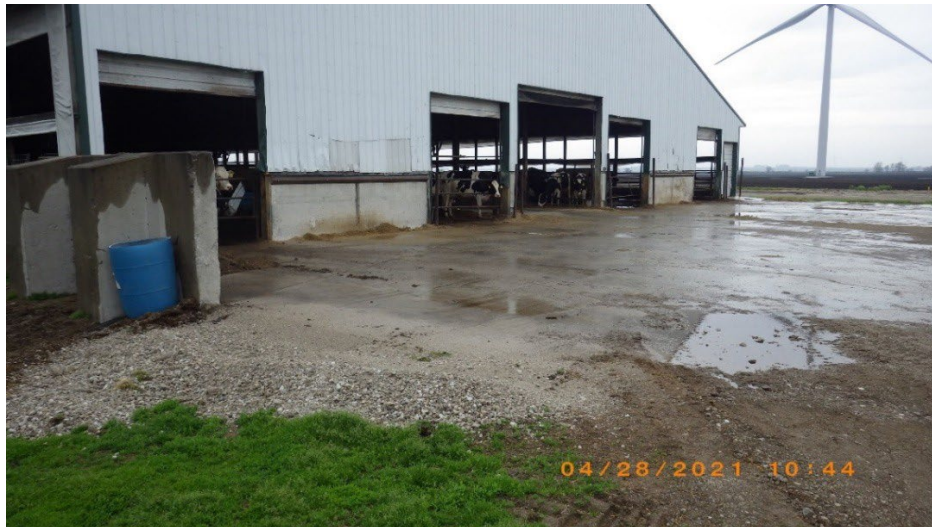
Photo Number: RIMG0082

Description: Used bedding pushed out of Barn 1 on the east side of Barn 1.

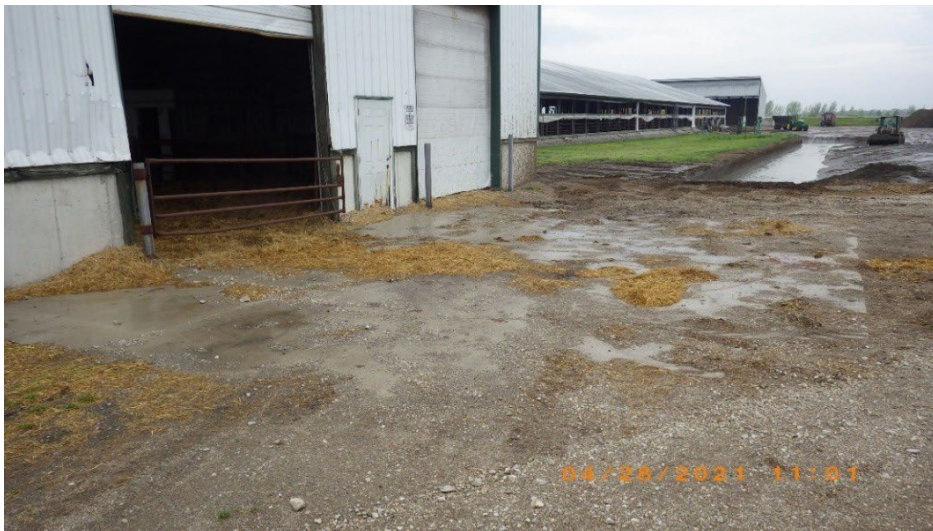
Photo Number: RIMG0085

EPA observed on the north side of Barn 5 that used bedding and feed had been pushed out the door (Photos RIMG0085 and RIMG0086). ^{Ex. 6. (Personal Privacy)} explained that when stormwater comes into contact with any track out on the north side, it surface flows by gravity into the Sand Separation Lane. We also observed the outlet into the Sand Separation Lane. The outlet is from the trenches that collect used bedding, manure, and process wastewater in the barns and flow by gravity into the Sand Separation Lane (Photo RIMG0087).

Description: Used bedding pushed out of the door of Barn 1.

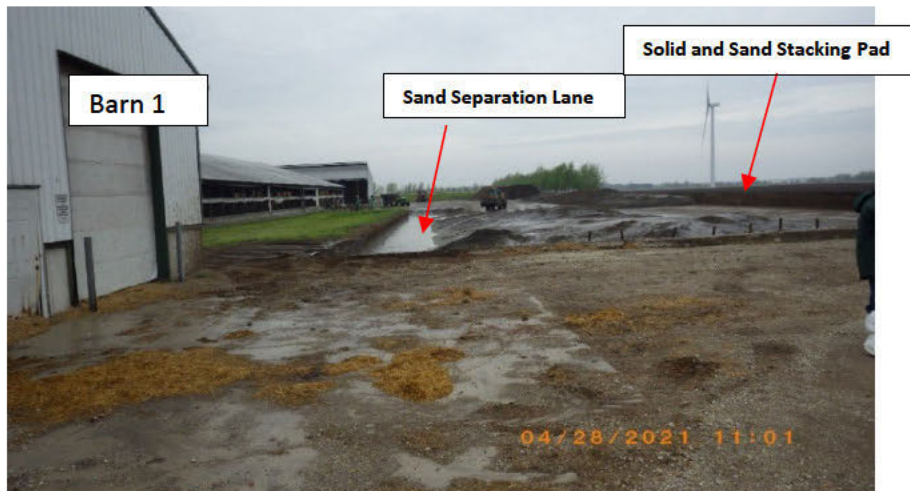
Photo Number: RIMG0086

Description: Used bedding and feed pushed out of Barn 1, the Sand Separation Lane and Solid and Sand Stacking Pad which are labeled in the photo above.

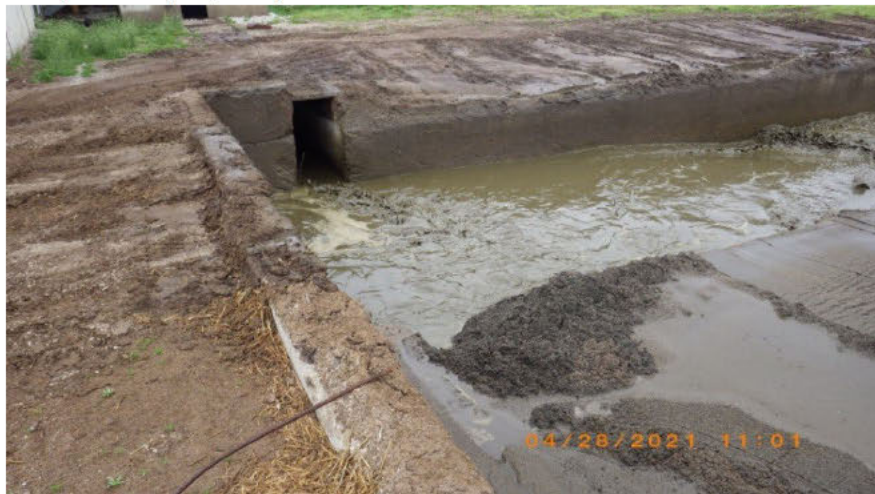
Photo Number: RIMG0087

Description: All the used bedding, manure, and process wastewater from Barns 1-5 is flushed with process wastewater from the Recirculation Pit and the 3rd Stage Lagoon and flows by gravity in the trench into the Sand Separation Lane.

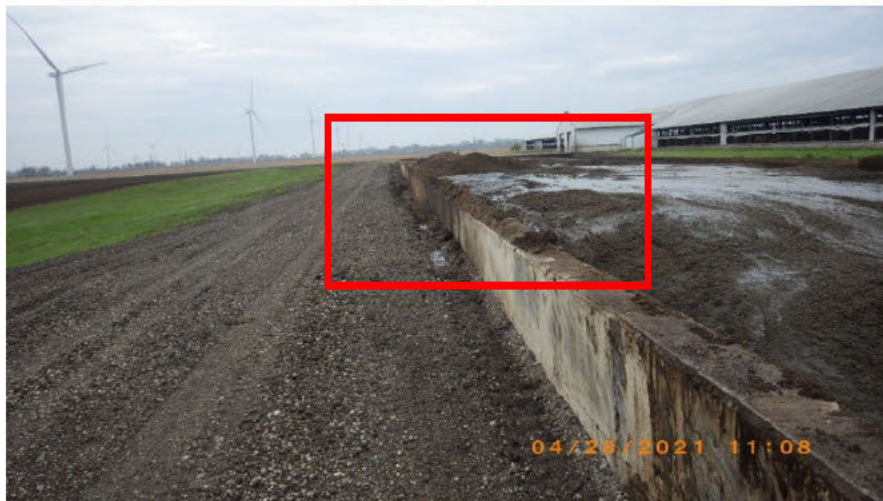
Photo Number: RIMG0091

EPA continued walking west on the north side of the facility and observed solids pushed over the concrete wall of the Solid and Sand Stacking Pad. ^{Ex. 6. (Personal Privacy)} explained that any stormwater that comes into contact with the solids been pushed over the wall would flow to the Stormwater Pond (Photo RIMG0091). We walked on the Solid and Sand Stacking Pad to observe how the process wastewater is pumped into the 1st Stage Lagoon (Photos RIMG0095 and RIMG0096).

Description: In the red outline box in the photo above, some solids from the Solid and Sand Stacking Pad spilled over the concrete wall onto the North Access Road.

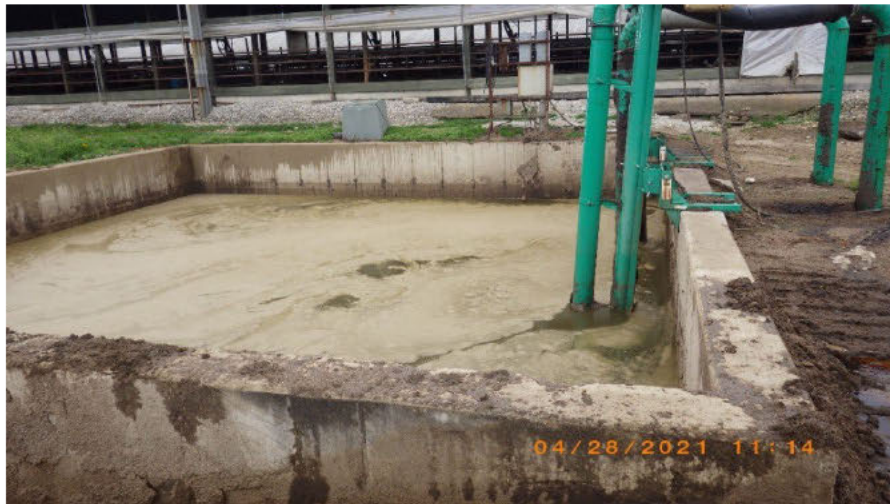
Photo Number: RIMG0096

Description: This is where the process wastewater from the Sand Separation Lane is pumped to the 1st Stage Lagoon.

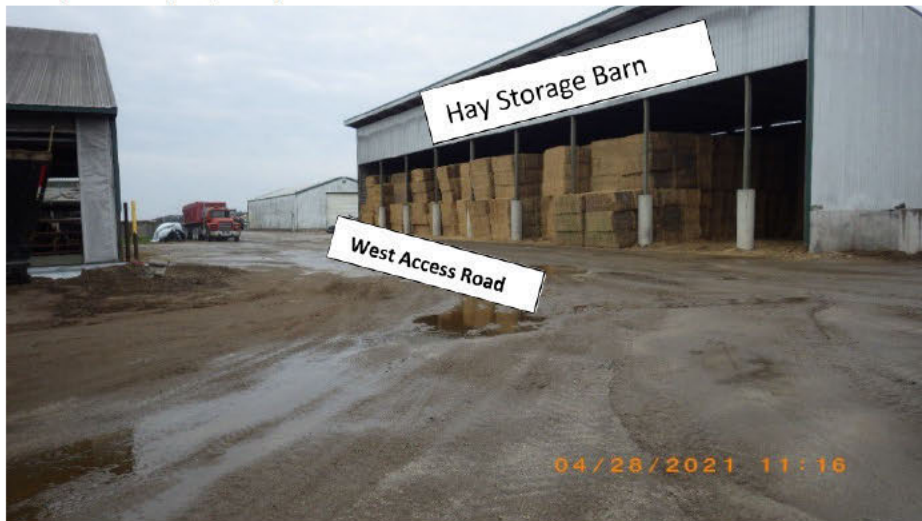
Photo Number: RIMG0097

Description: Any process wastewater on the West Access Road flows into the Stormwater Pond. The Hay Storage Barn is labeled in the photo along with the West Access Road.

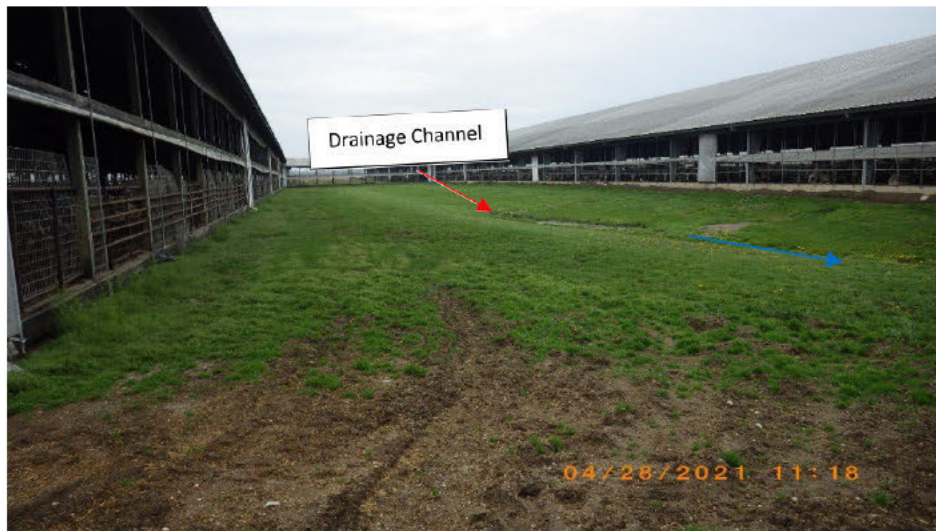
Photo Number: RIMG0098

Description: The drainage channel between Barn 1 and Barn 2 is labeled with the arrow showing the direction of flow. The flow within the drainage channel conveys flow to a drainage inlet pipe that conveys flow to the Stormwater Pond.

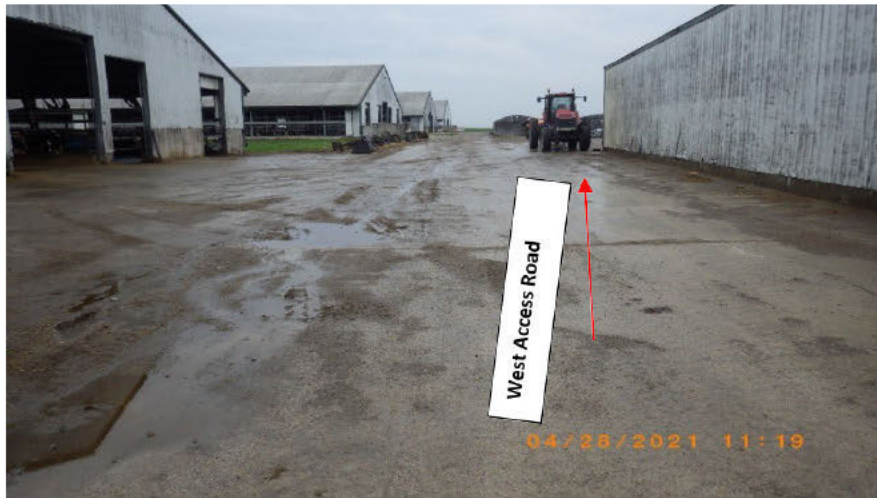
Photo Number: RIMG0100

Description: The overall view of the West Access Road. Flow is to the south (as shown in the photo by the red arrow) into a drainage tile that conveys flow to the Stormwater pond.

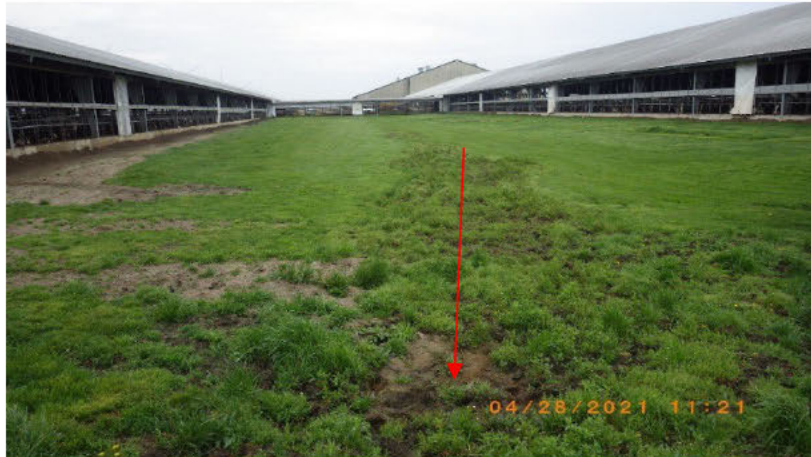
Photo Number: RIMG0104

Description: The red arrow in the photo above shows the direction of flow within the drainage pathway between Barn 2 and Barn 3.

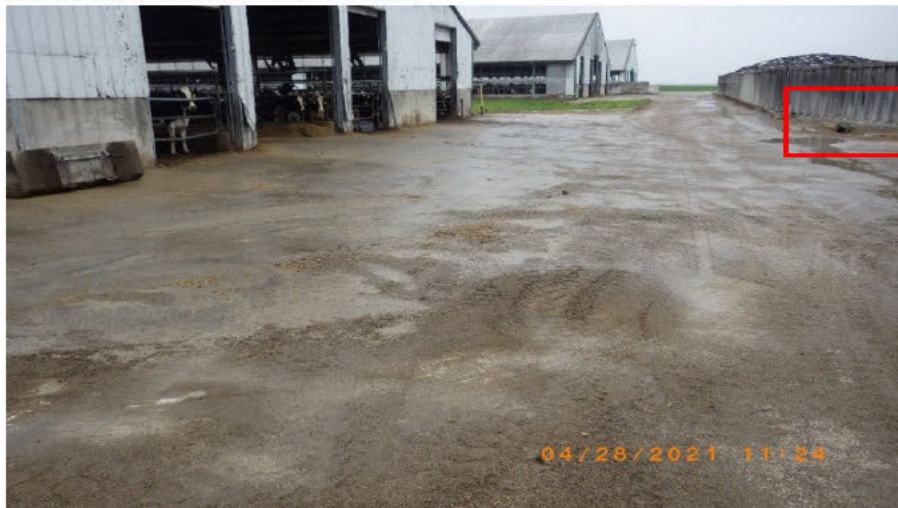
Photo Number: RIMG0105

Description: The feed and used bedding pushed out of the Barn 2 and Barn 1 and drains to the southwest and drains to Stormwater Pond through tile inlets. One of the tile inlets is in the red box.

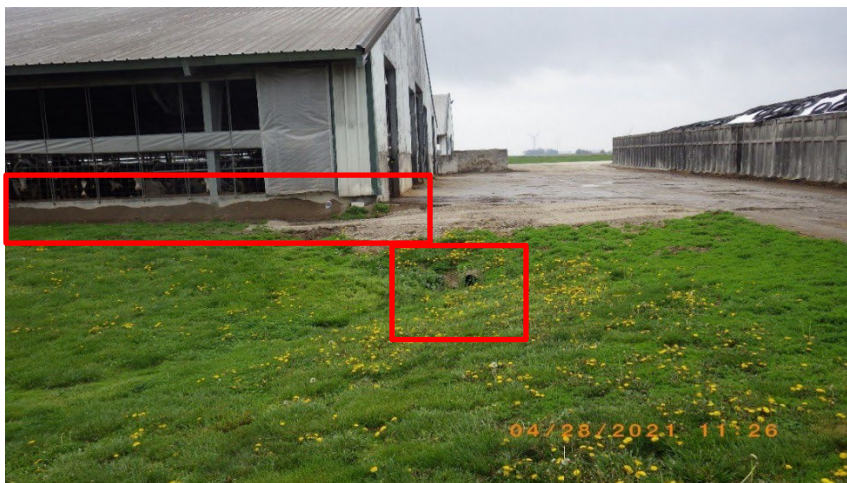
Photo Number: RIMG0109

Description: The drainage tile inlet near the northwest corner of Barn 3 and used bedding being pushed out of Barn 3 shown inside the red outlined boxes in the photo above.

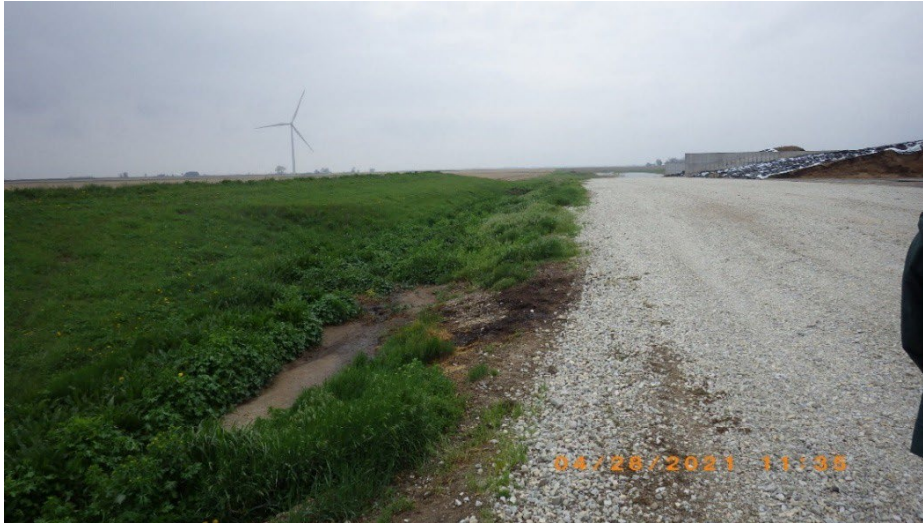
Photo Number: RIMG0118

Description: The South Drainage ditch surface flows to the west into the Stormwater Pond.

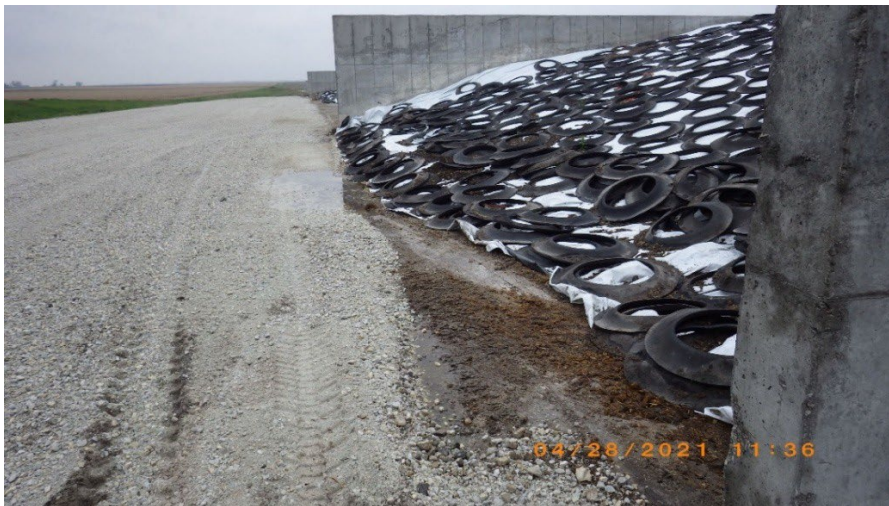
Photo Number: RIMG0119

We continued our walk-through to the south side of the Stormwater Pond and observed leachate from the silage stored in the silage bunkers. Any leachate, stormwater, and/or stormwater that comes into contact with the feed in the bunkers flows either into the South Drainage Ditch (Attachment B) or along the South Access Road (Attachment B) and into the Stormwater Pond (Photos RIMG0119 through RIMG0128).

Description: Feed exposed on the ground outside of the Silage Bunkers.

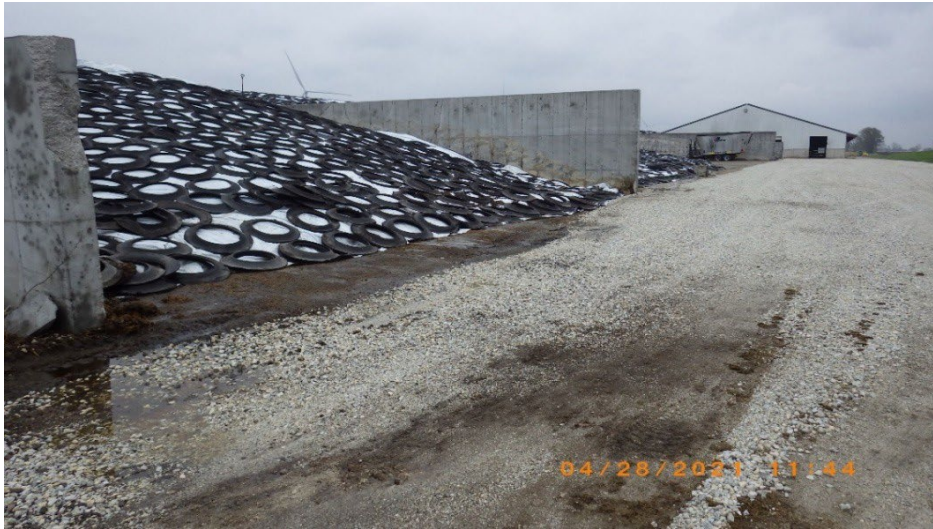
Photo Number: RIMG0122

Description: Process wastewater drains to the west into the Stormwater Pond.

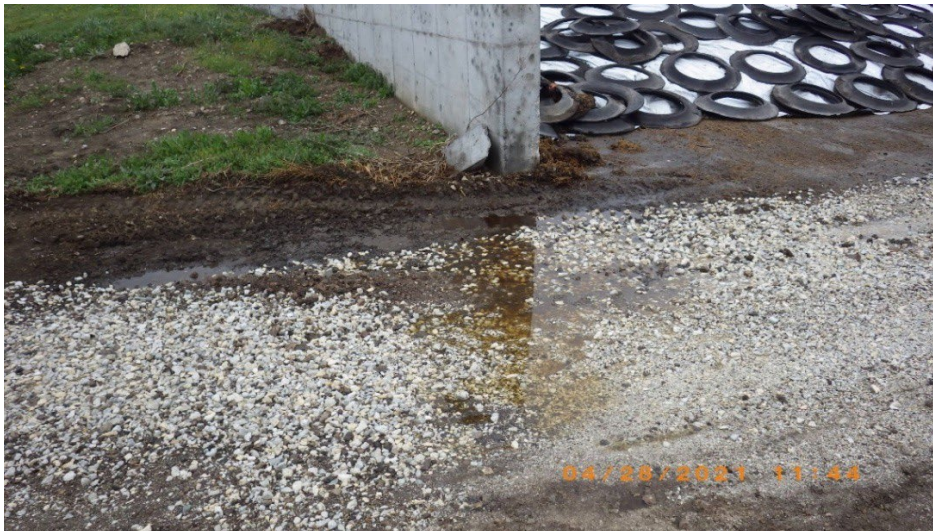
Photo Number: RIMG0123

Description: The process wastewater coming off of the silage stored in the Silage Bunkers flows to the west into the Stormwater Pond.

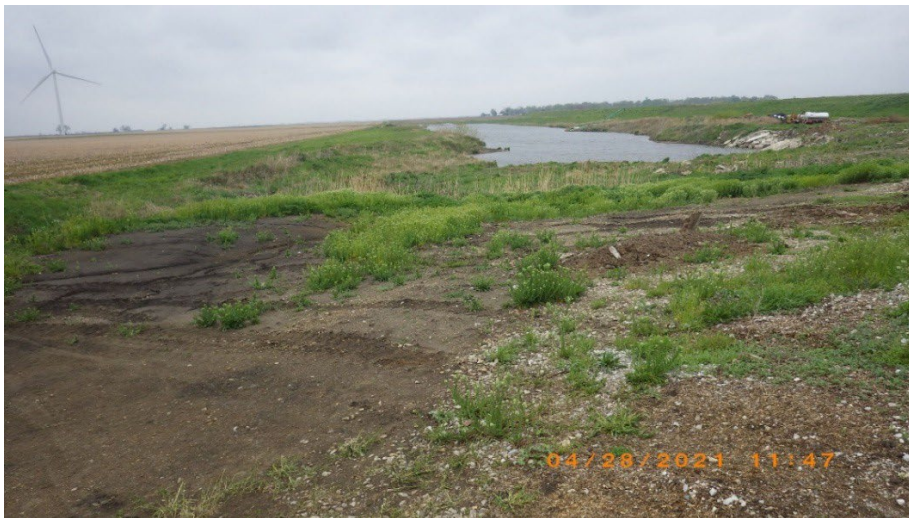
Photo Number: RIMG0125

Description: The feed outside of the Storage Bunkers, which mixes with stormwater and flows into the Stormwater Pond.

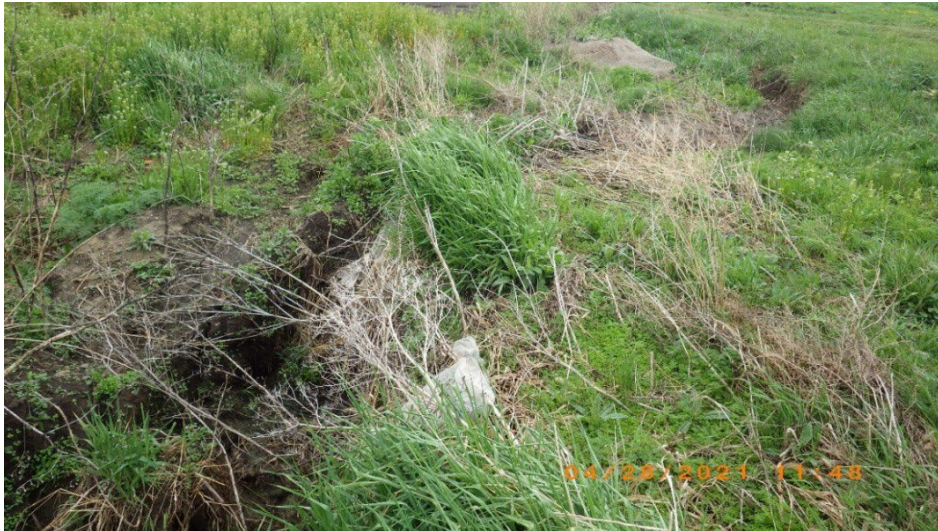
Photo Number: RIMG0126

Description: The eroded drainage channel that flows into the Stormwater Pond.

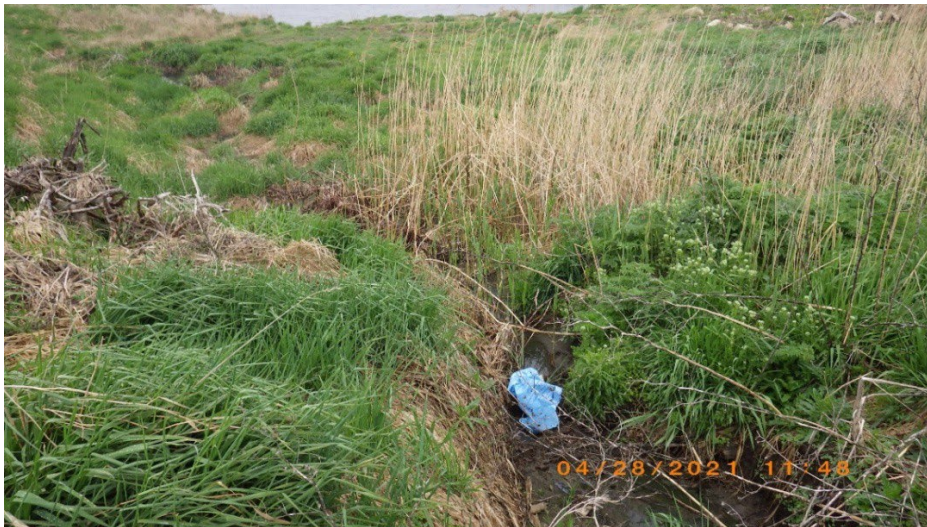
Photo Number: RIMG0127

Description: The continuation of the eroded drainage channel that carries flow into the Stormwater Pond.

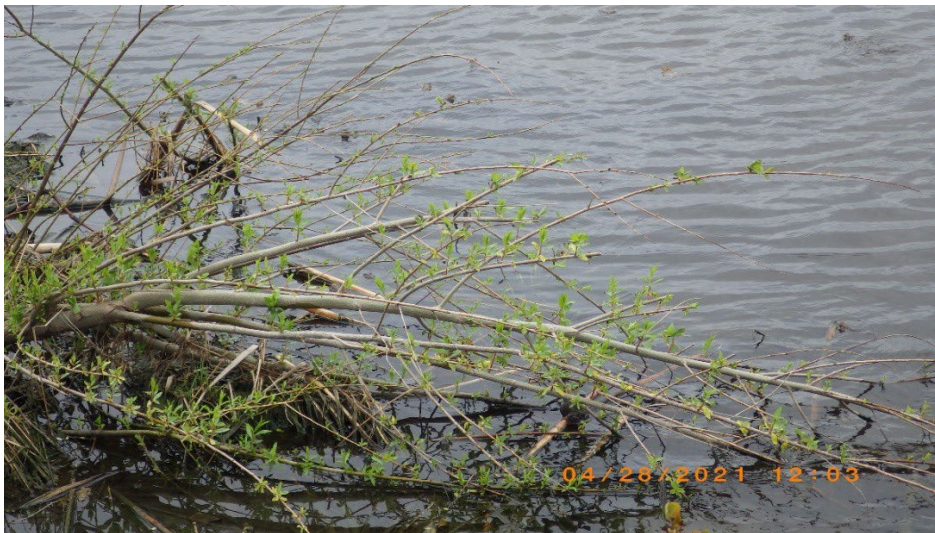
Photo Number: RIMG0131

As we were walking on the south side of the Stormwater Pond, we observed approximately one hundred frogs/toads within the Stormwater Pond (Photos RIMG0129 through RIMG0132). We continued to the southwest side of the Stormwater Pond where we observed the tile outlet into the Stormwater Pond. Mr. Boerman explained that the

Description: Trying to show the frogs within the Stormwater Pond.

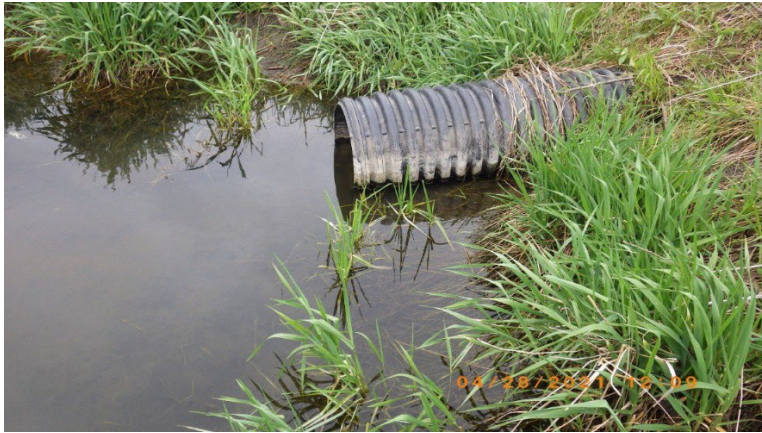
Photo Number: RIMG0136

agricultural field to the south was tiled to flow into Prudential Ditch (Photos RIMG0135 and RIMG0136), but this tile has been plugged and is now tiled to flow into the Stormwater Pond (Photo RIMG0133). We observed an access ramp into the Stormwater Pond, which Ex. 6 (Personal Privacy) explained farmers use to access the Stormwater Pond for irrigating their crops (Photo RIMG0134).

Description: The close-up of the tile outlet into Prudential Ditch that has been plugged and rerouted to drain into the Stormwater Pond.

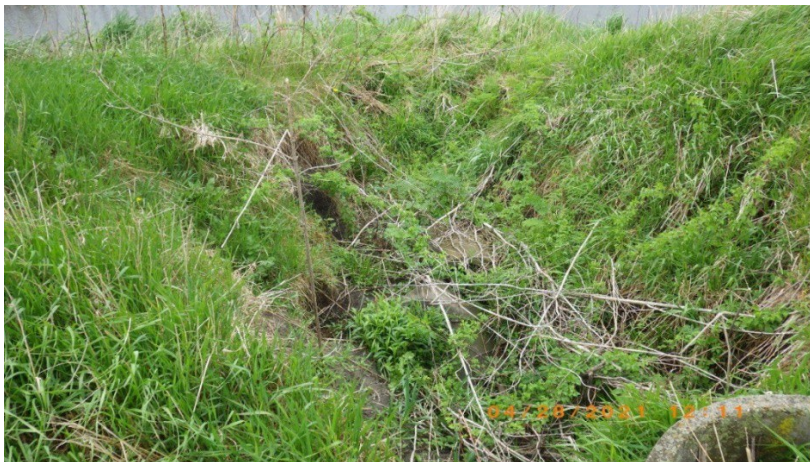
Photo Number: RIMG0137

Description: The erosion channel into Prudential Ditch, west of the Stormwater Pond.

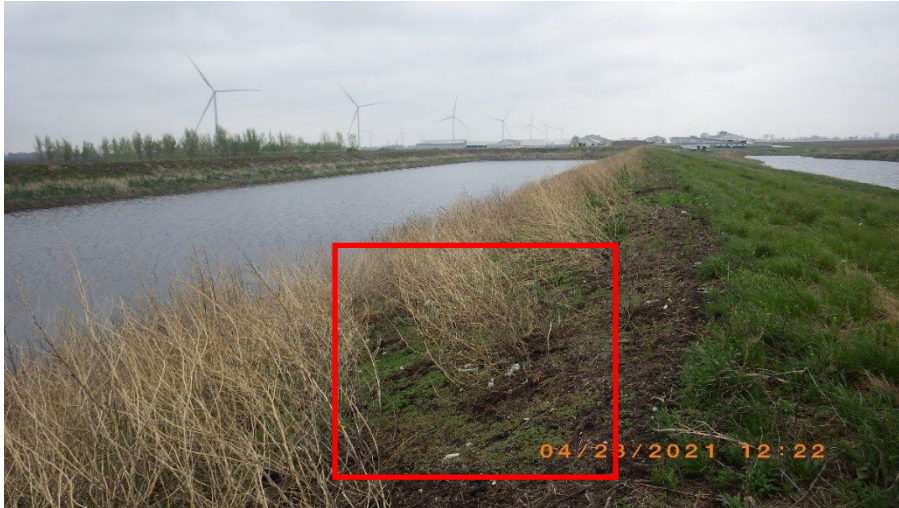
Photo Number: RIMG0140

We continued to the 5th Stage Lagoon to observe the berms. We observed vegetation that at first appeared to possibly be impacting the berm. Ex. 6 (Personal Privacy) and Mr. Severson showed that the vegetation was not rooted to the liner but was in the compost that was used as additional protection of the berms (Photo RIMG0139). The compost on the berms contained bones from the cows that were composted in the mortality pile (Photo RIMG0140).

Description: Mortality compost is used on top of the clay liner of the 5th Stage Lagoon. In the red outlined box, there are white cow bones.

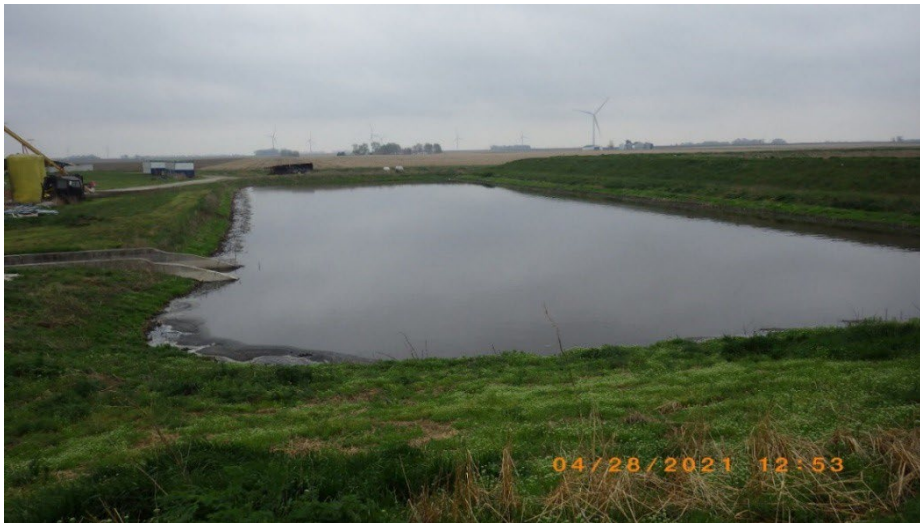
Photo Number: RIMG0163

Description: Silage Leachate Collection Pond for the collection of the leachate from the Concrete Feed Storage Area.

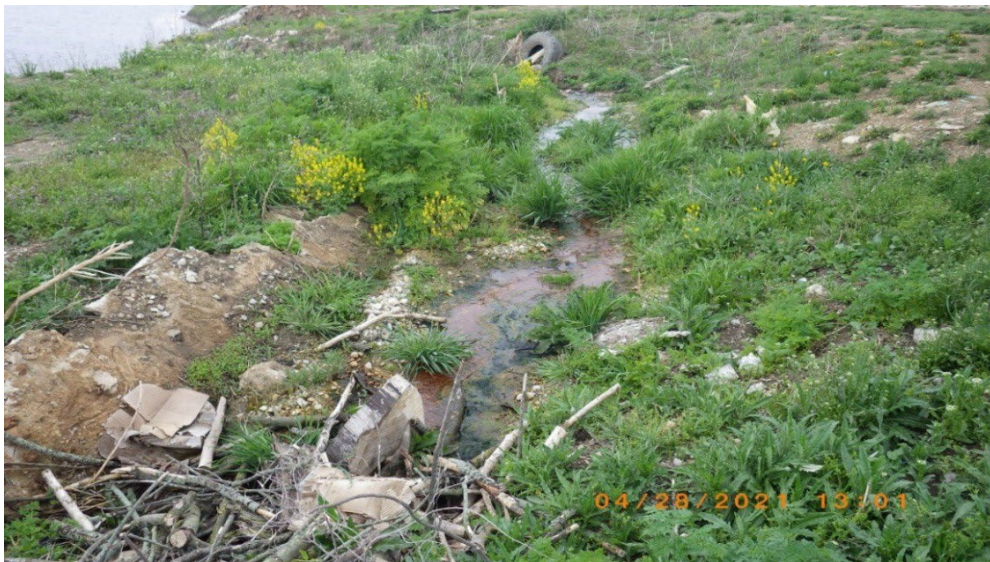
Photo Number: RIMG0171

Description: An eroded channel that conveys surface flow into the Stormwater Pond.

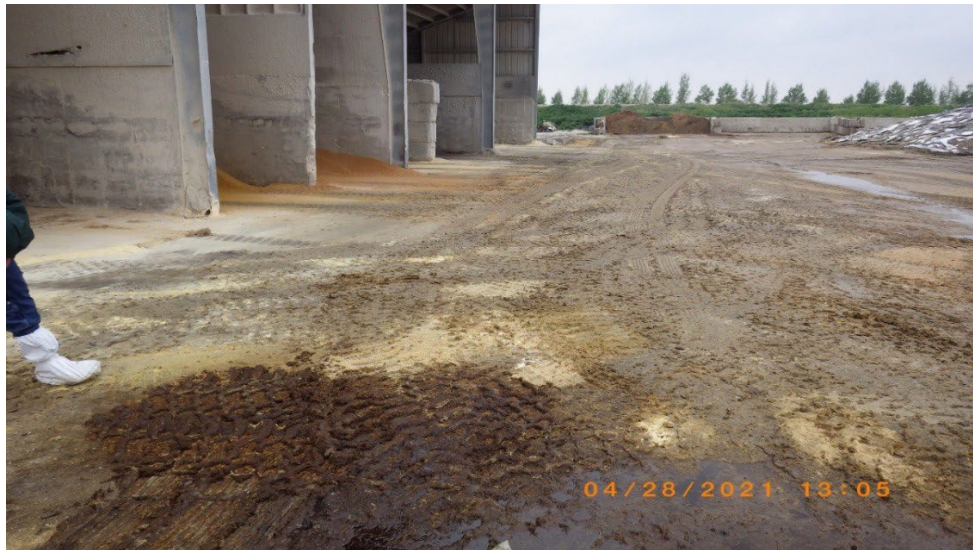
Photo Number: RIMG0172

Description: The commodity shed on the northwest side of the concrete Feed Storage Area.

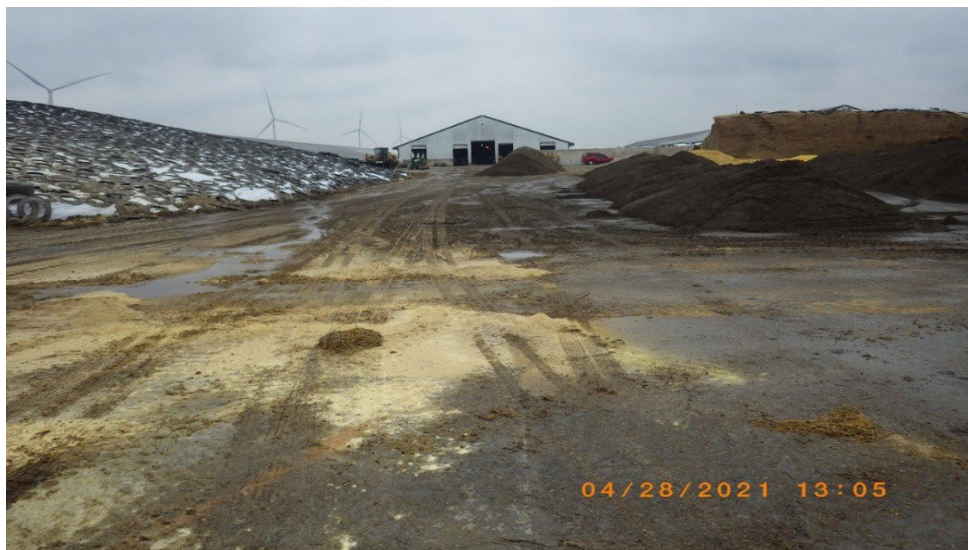
Photo Number: RIMG0173

Description: Concrete Feed Storage Area.

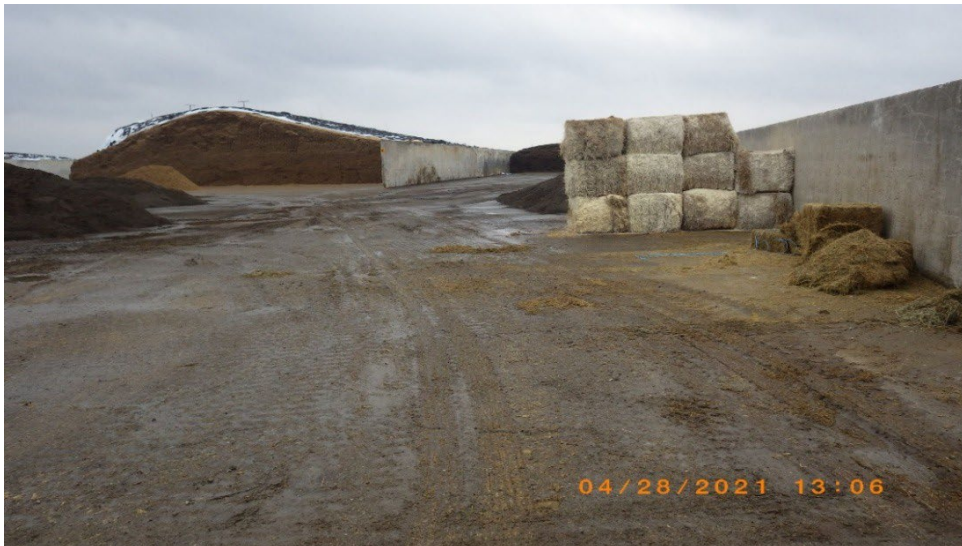
Photo Number: RIMG0174

Description: The concrete Feed Storage Area.

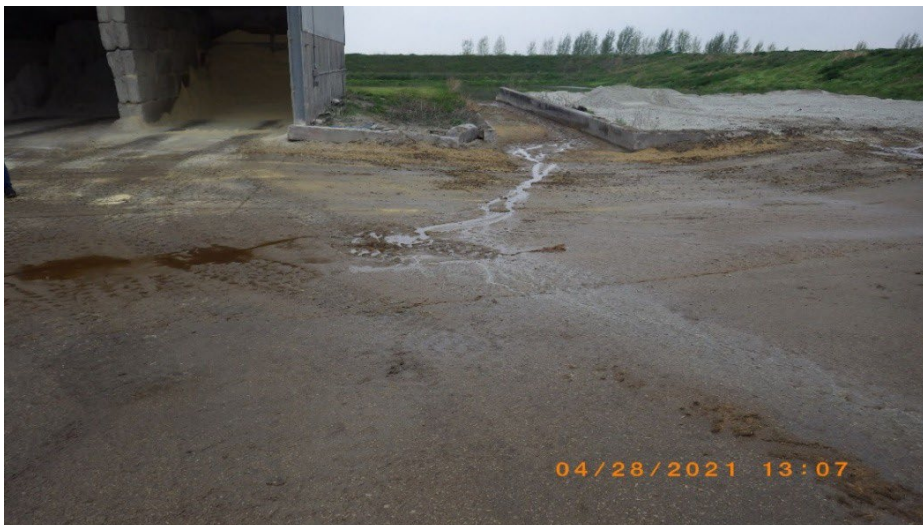
Photo Number: RIMG0175

We observed a few of the manholes within the concrete Feed Storage Area and observed flow into the manholes. These manholes are connected to the Sileage Leachate Collection Pond.

Description: The manhole on the concrete Feed Storage Area that conveys flow to the Silage Leachate Collection Pond.

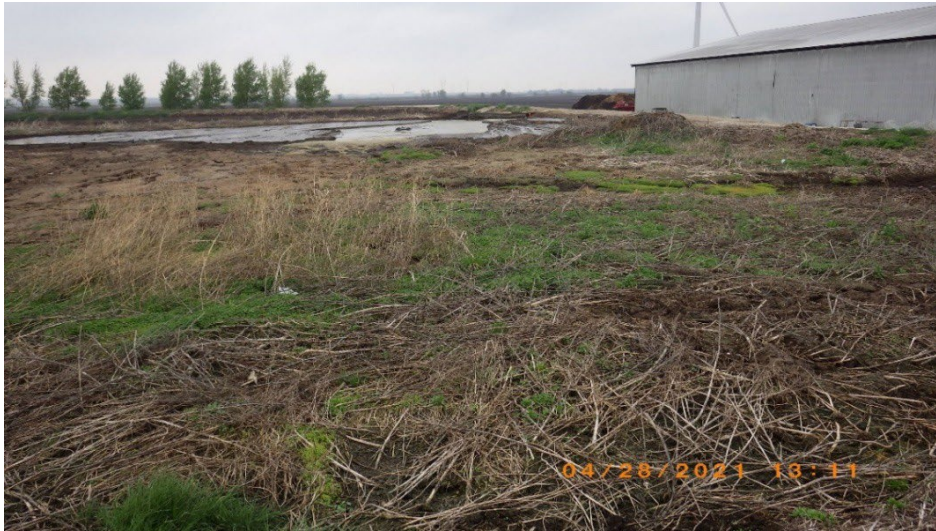
Photo Number: RIMG0176

Description: The 1st Stage Lagoon and Commodity Shed.

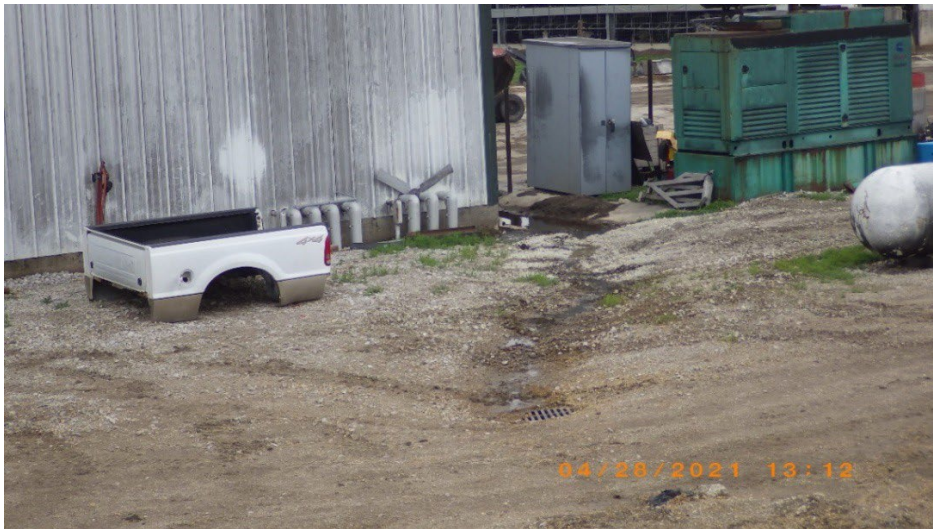
Photo Number: RIMG0176

Description: The pump to the 1st Stage Lagoon from the Sand Separator and drains flow to the Stormwater Pond.

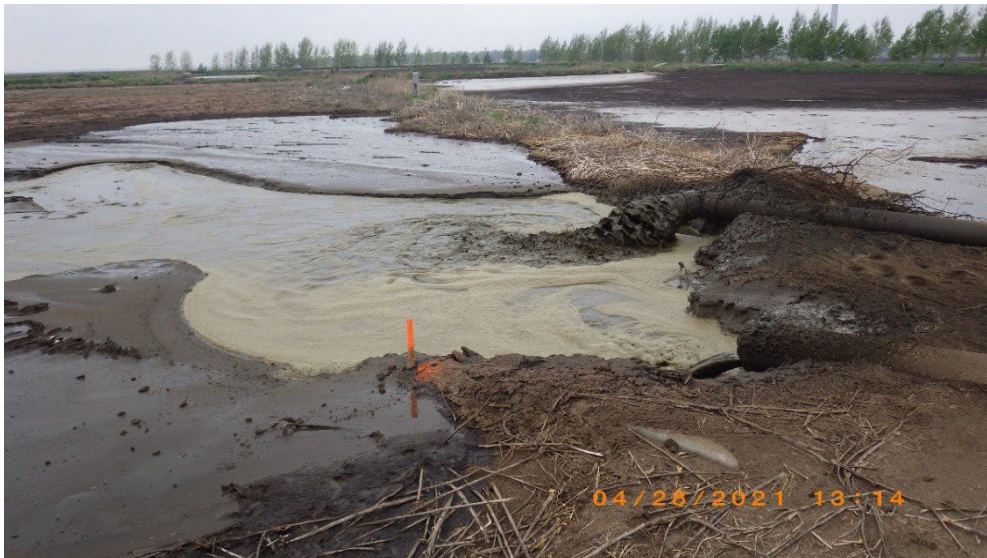
Photo Number: RIMG0178

Description: The depth gage for the 1st Stage Lagoon.

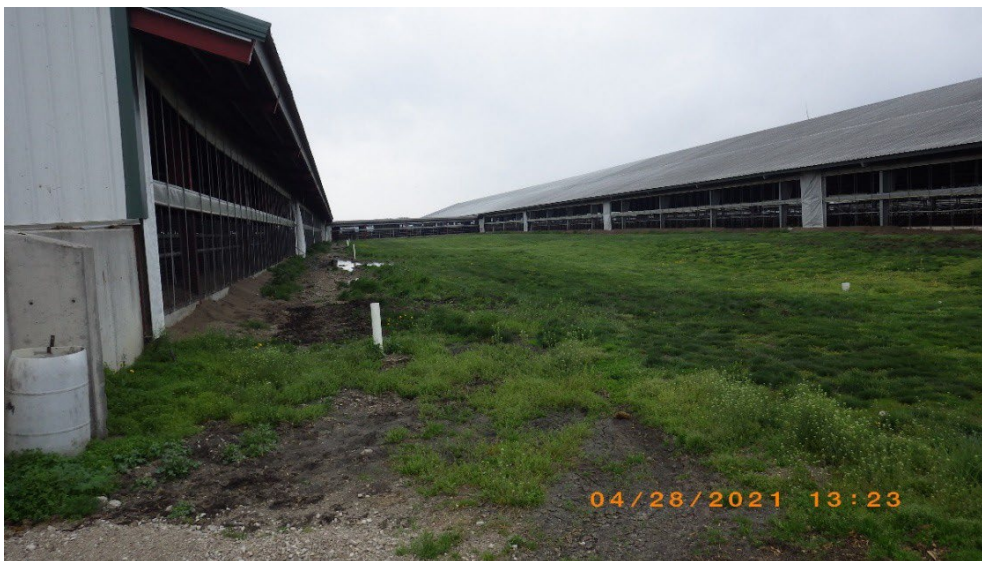
Photo Number: RIMG0179

Description: The drain pipe between Barn 4 and Barn 5.

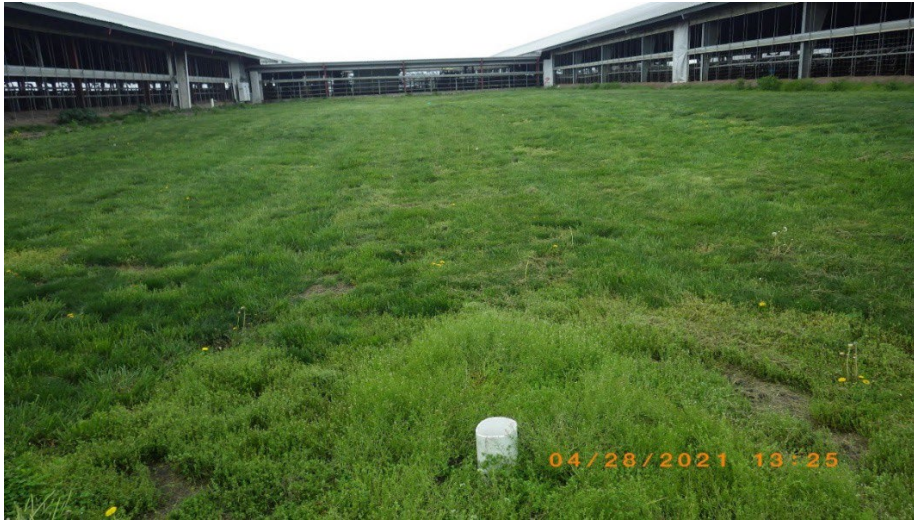
Photo Number: RIMG0180

Description: The drainage tile inlet between Barn 4 and Barn 5 on the east side of the barns.

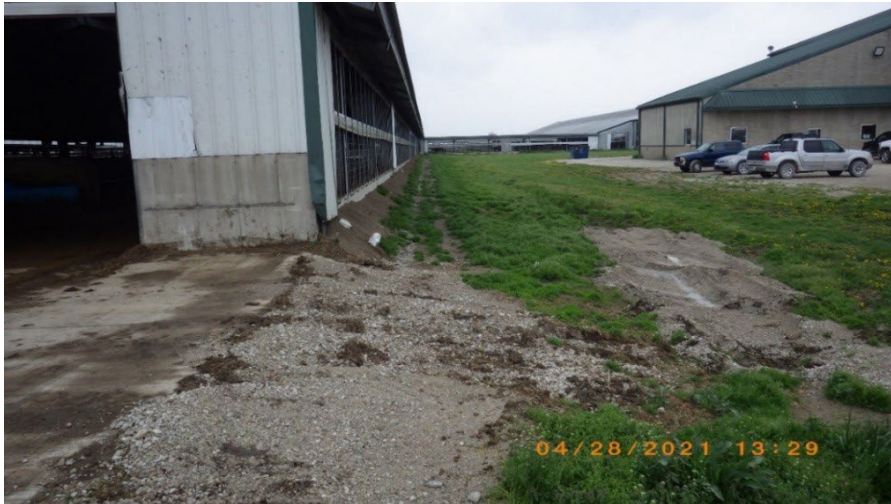
Photo Number: RIMG0181

Description: Stormwater that comes into contact with used bedding and feed pushed out of Barn 4 flows to the north and to the east through the drainage tile inlet that runs under the East Access Road and outlets into the East Drainage Channel that flows into the Stormwater Pond.

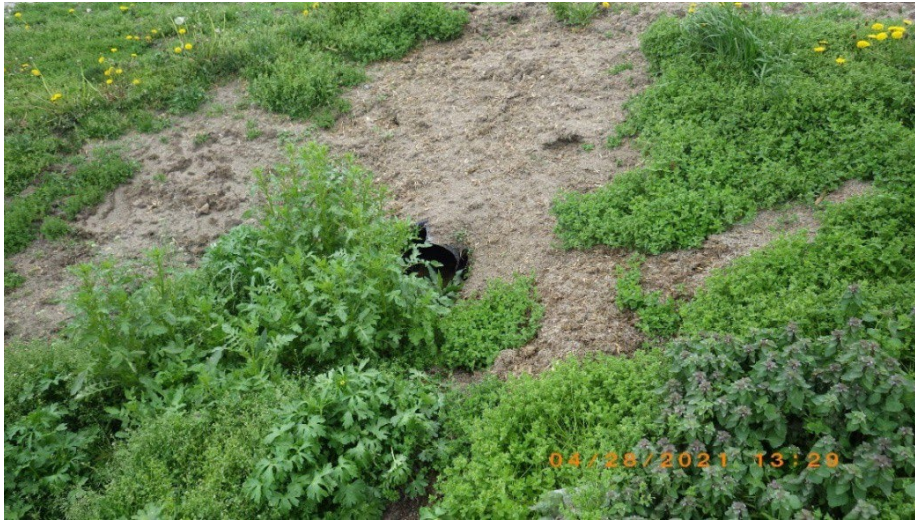
Photo Number: RIMG0182

Description: The drainage inlet from between Barn 4 and Barn 3.
